VINA. INDUSTRIAL ACTIVITY COPY

INDUSTRIAL ACTIVITY  
NORTH VIETNAM

CIA/PIR 75077

DATE JAN. 1967

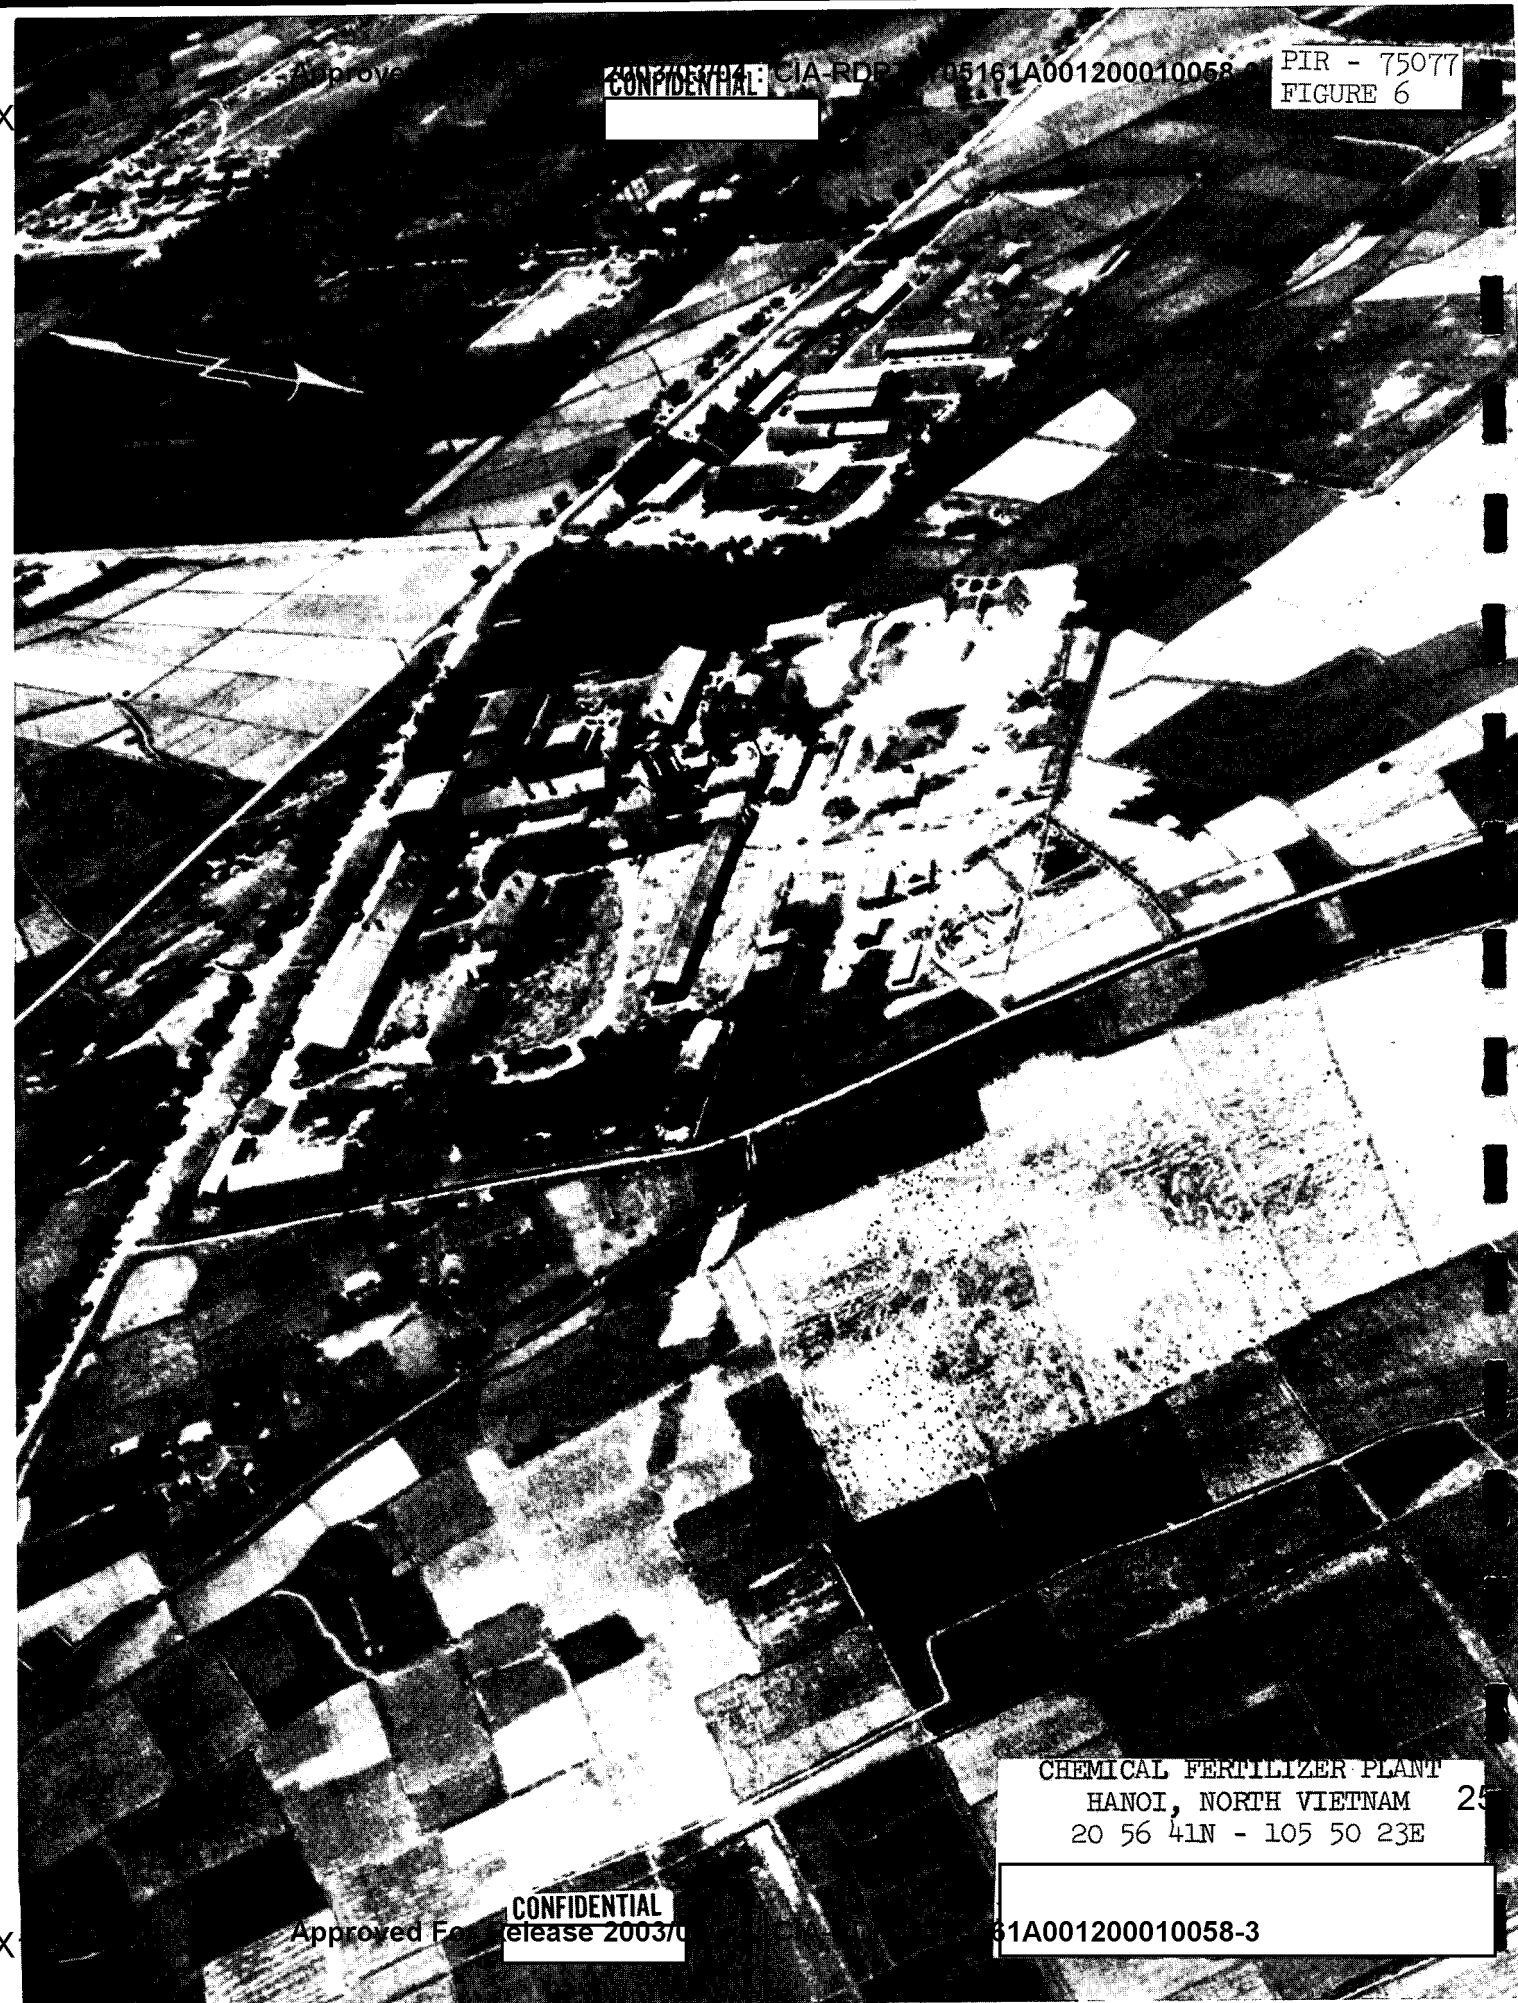
PIR - 75077  
FIGURE 6

Photography [ ] (Figure 6) showed no smoke coming from the large stack in the center of the plant and no vehicular traffic in the area. A number of packing crates was noted scattered in open storage and the raw materials stock appeared to be depleted (IB memo - 340/66).

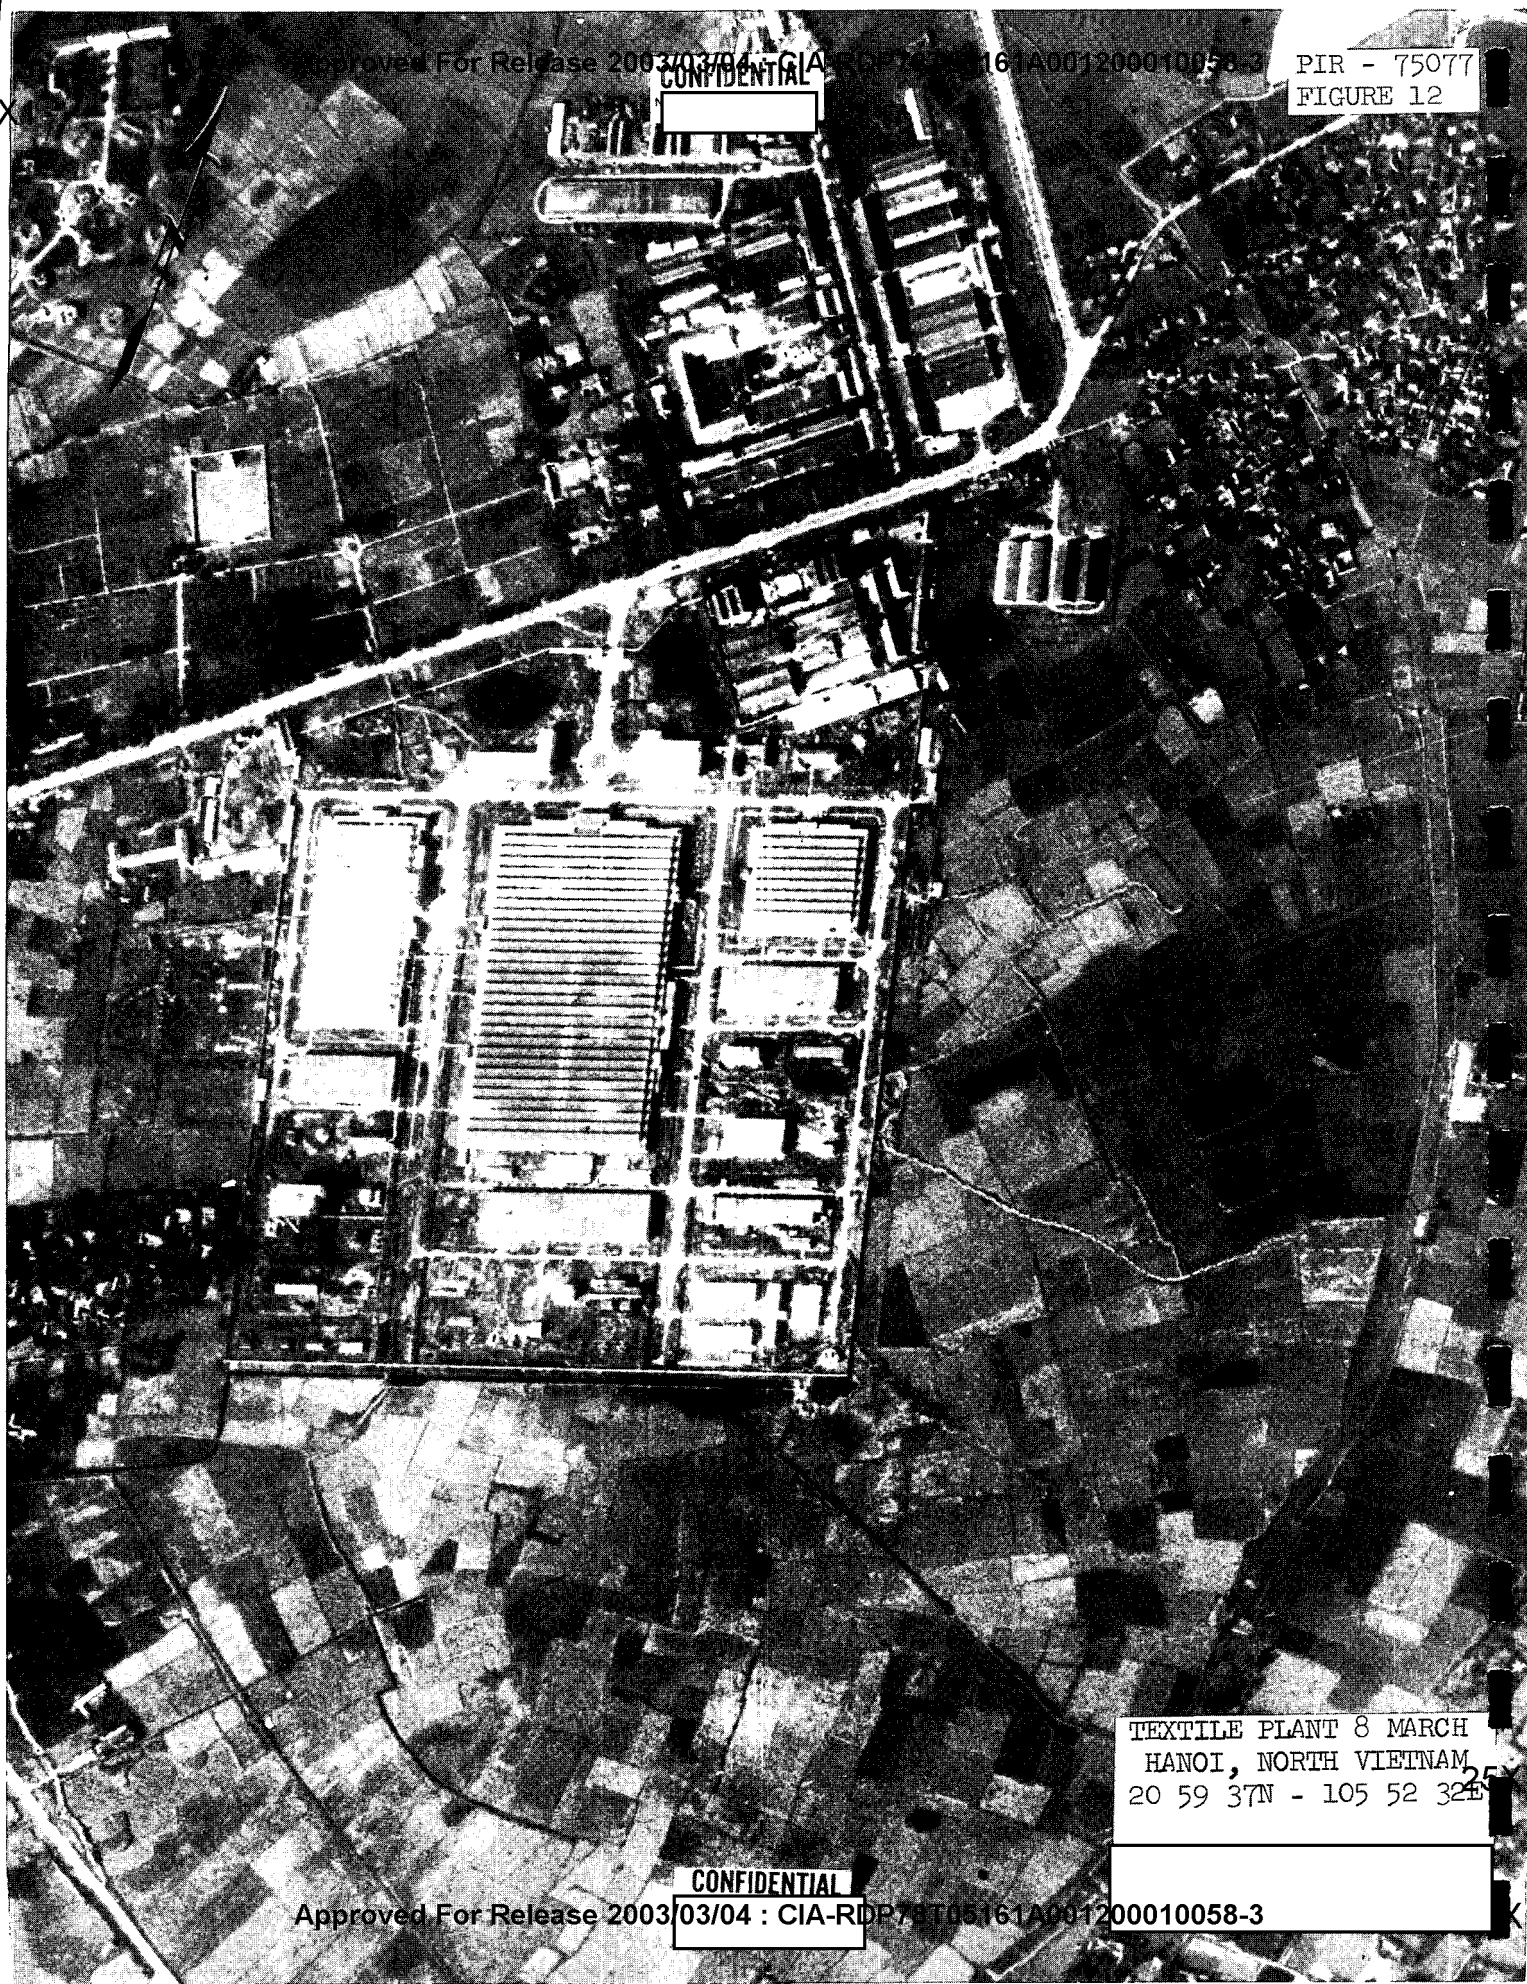
PIR - 75077  
FIGURE 12

This facility was first studied on photography of [ ] (Figure 12) which provided little concrete information as to the level of production.

There appeared to be considerable track activity and very little overgrowth of vegetation in the plant area. No smoke was noted coming from the heat and power plant. River traffic in the area was heavy, but not necessarily associated with the textile mill.

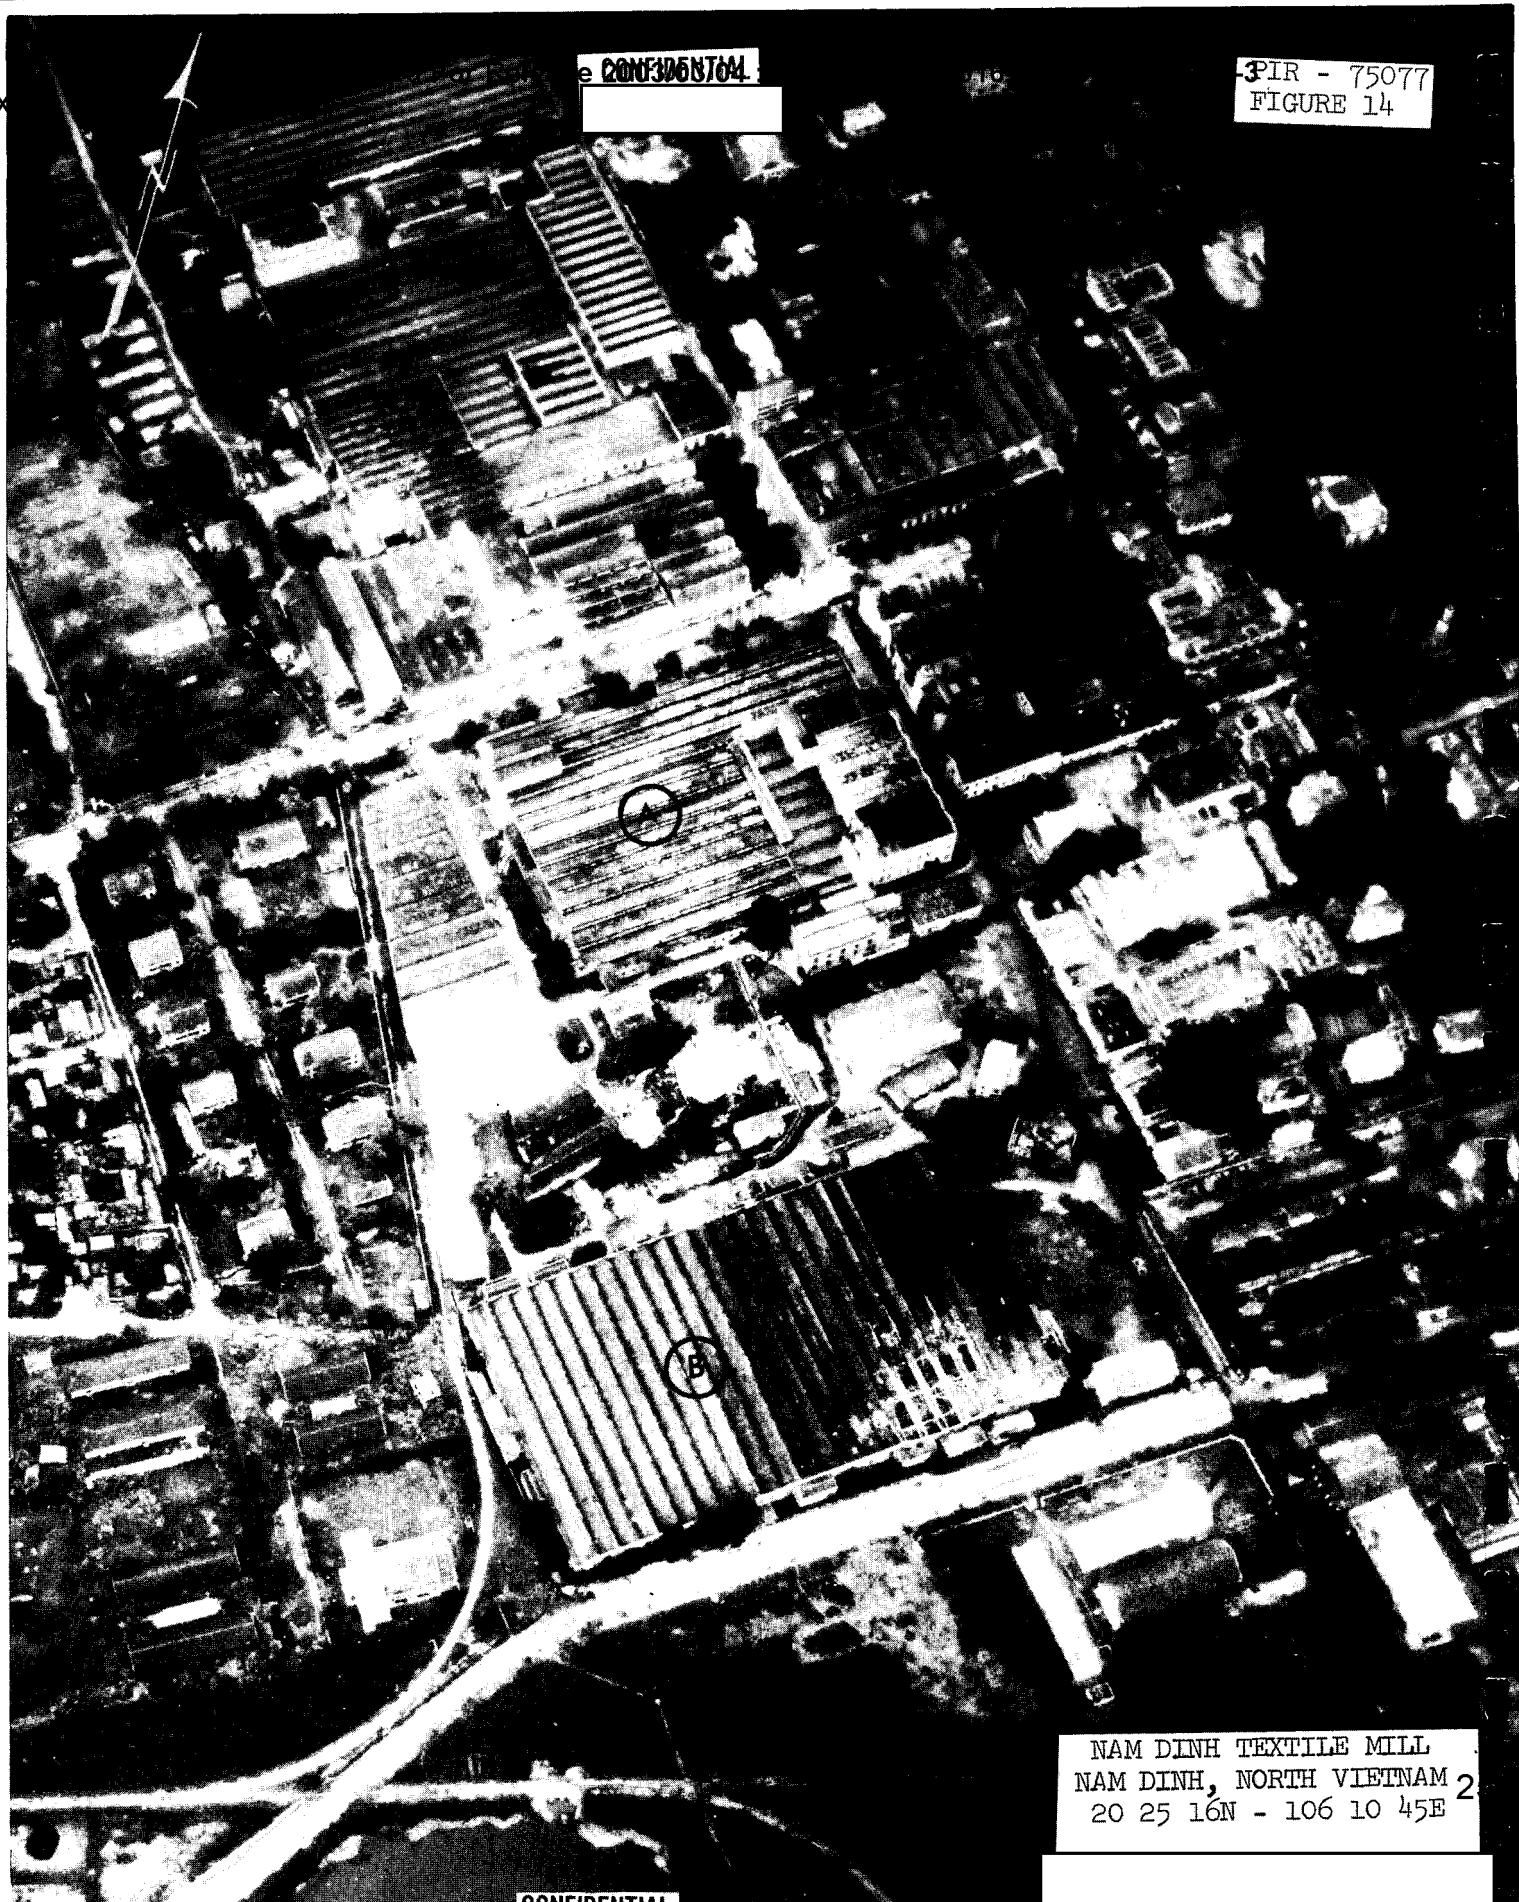
PIR - 75077  
FIGURE 14

A study of this installation was made using photography [ ]  
[ ] The [ ] coverage (Figure 14) revealed very little to indicate the plant's activity, but did show bomb damage to several buildings.

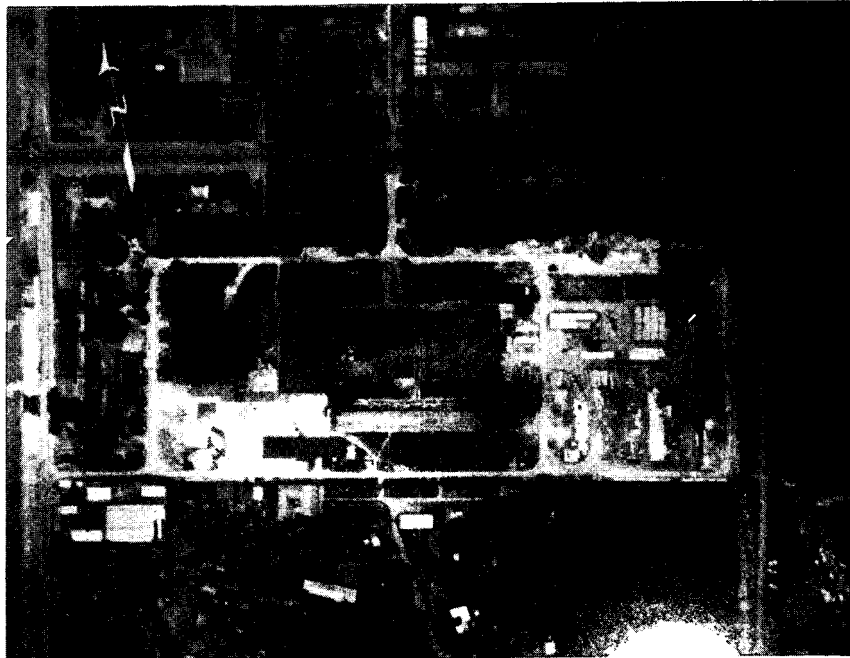
PIR - 75077  
FIGURE 18

On photography [REDACTED] (Figure 18) there were no ships at the loading and unloading facilities, and no smoke was observed coming from the stacks. All of the raw material was in an orderly arrangement in open storage (See IB memorandum 340/66). By [REDACTED] (Figure 18) a major change had occurred in that all raw material in the open storage area appeared to have been moved or depleted. Only small photo prints of this plant are included in this report due to the poor image quality.

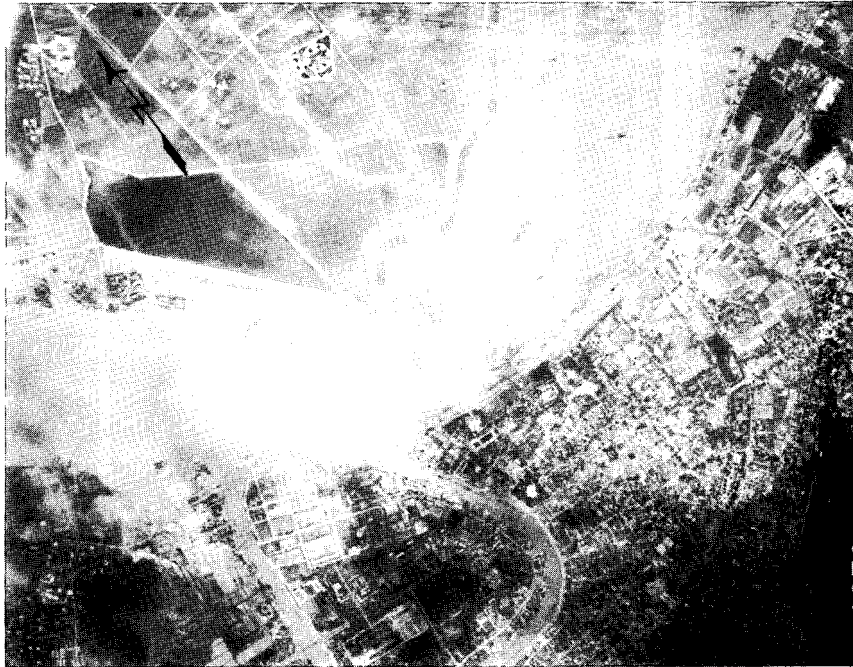
PIR - 75077  
FIGURE 19

Photography [REDACTED] (Figure 19) revealed that two small coastal freighters, four unidentified ships and a merchant ship were in the cargo berths in the Haiphong port. The two freighters were North Vietnamese and the merchant ship was Russian. Also, a number of barges were noted scattered throughout the area. There was approximately the same number of ships and small craft observed on photography [REDACTED] (Figure 19).

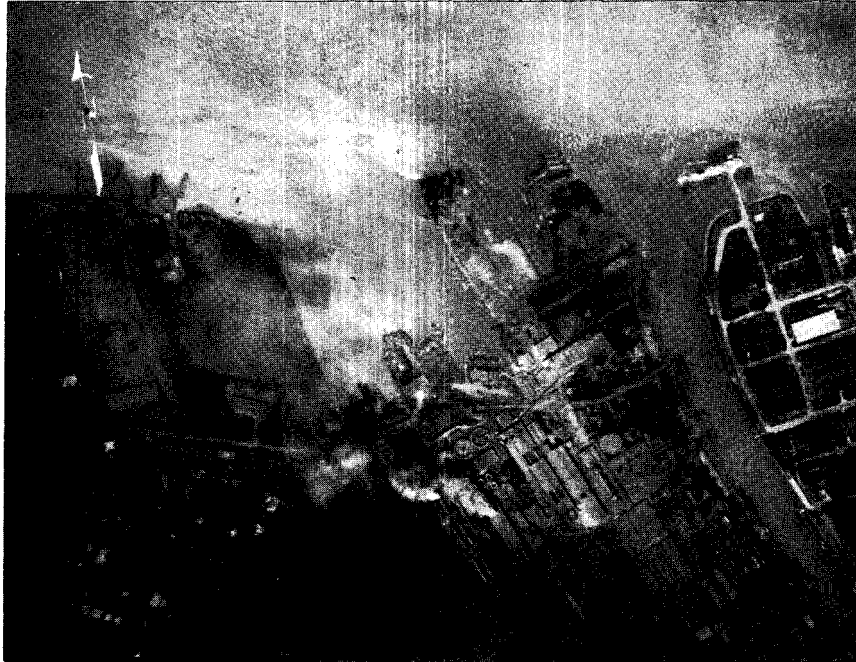
Smoke from the kilns was evident on photography [REDACTED]

Figure 20). Also a number of barges

were noted at the mooring area adjacent to the plant. No new construction could be discerned during the referenced period. Because of poor image quality and infrequent coverage of this facility, it is difficult to make any conclusive statements concerning the number of kilns operating.
